Att. 1 – Ben Weitsman of Syracuse, Geddes, NY
August 17, 2016, Unedited Digital Photos taken with
Nikon Coolpix P510 Digital Camera by
Murray Lantner, P.E. Env. Eng.
EPA Region 2, DECA-WCB

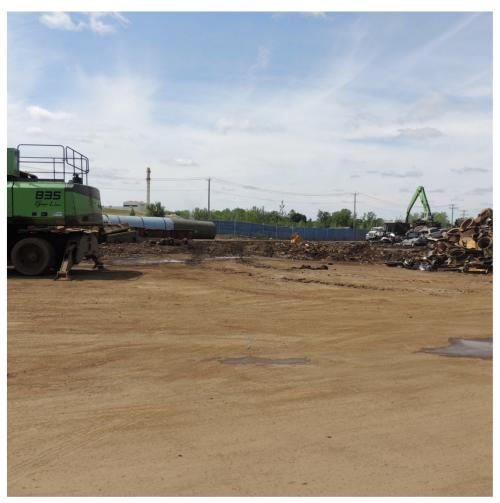
DSCN3607 – Scrap piles, some on paved and some on unpaved surfaces

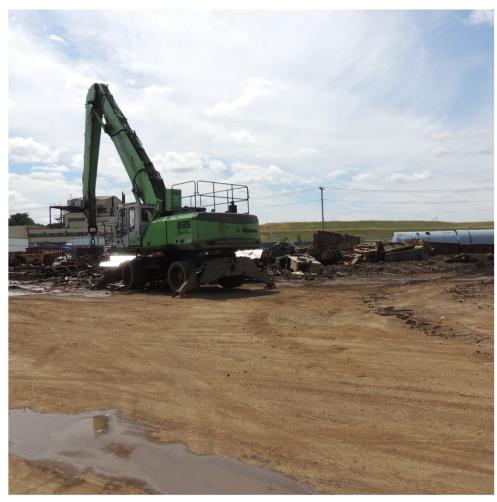
DSCN3608 - Scrap piles, some on paved and some on unpaved surfaces

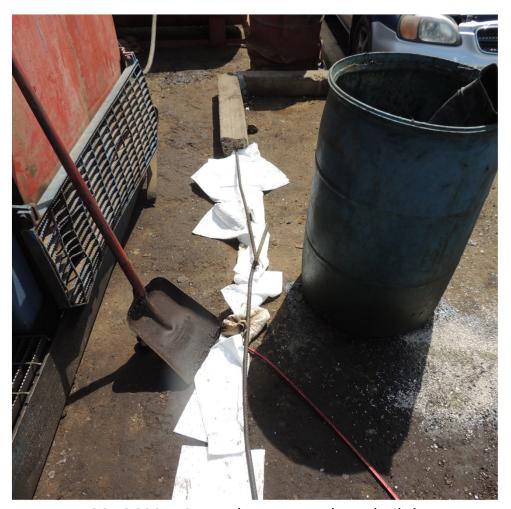
DSCN3609 – Car rack area – pads and oil dry

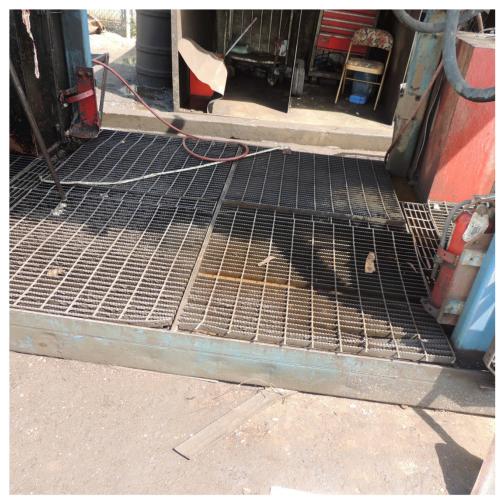
DSCN3610- — Car rack area — with containment to capture fluids

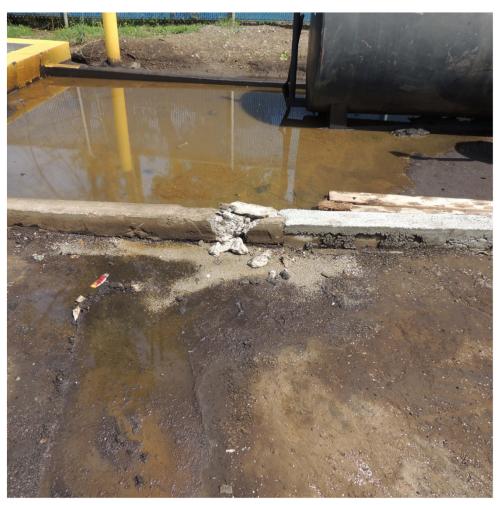
DSCN3611 – curbing in used oil collection area partially broken, needs fixing

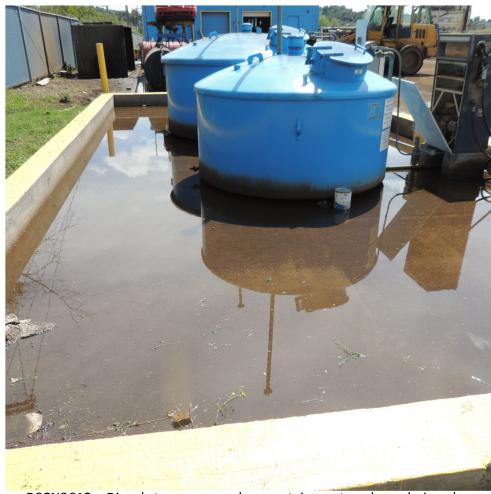
DSCN3612 – Diesel storage secondary containment – where drain valve was open

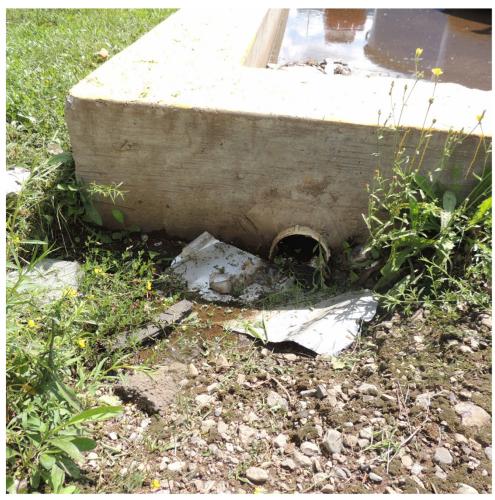
DSCN3613 - Diesel storage secondary containment – where drain valve was open

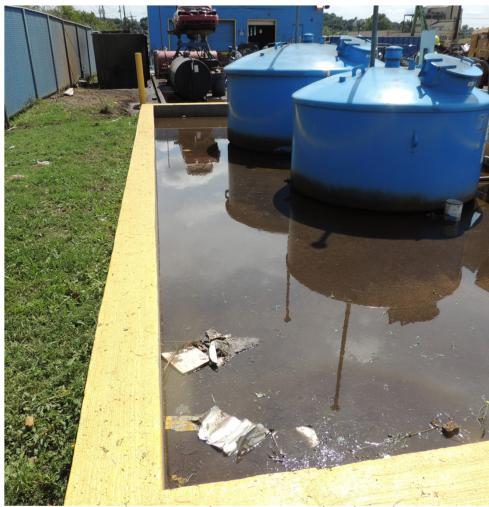
DSCN3614 - Diesel storage secondary containment – where drain valve was open, standing water with no sheens inside containment – debris inside containment needs to be cleaned.

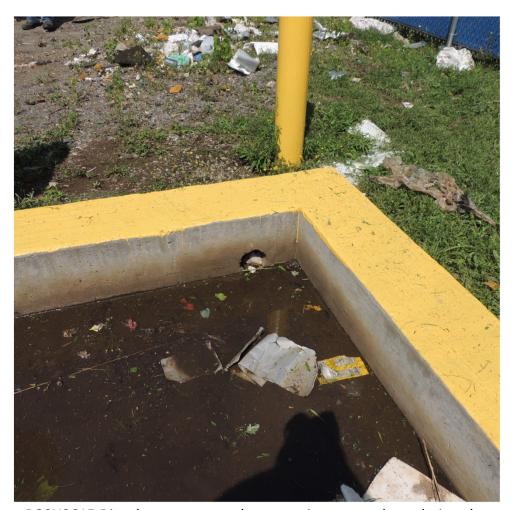
DSCN3615 Diesel storage secondary containment – where drain valve was open, standing water with no sheens inside containment – debris inside containment needs to be cleaned.

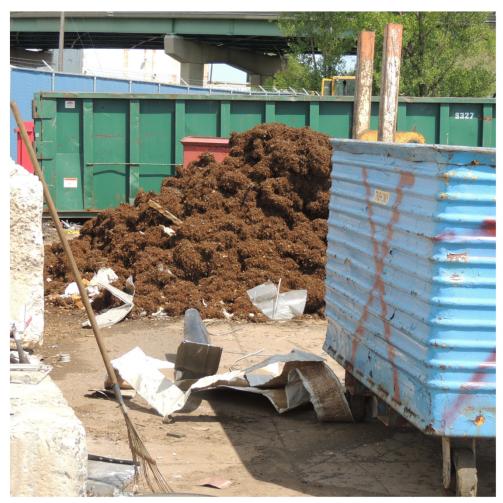
DSCN3617 – Metal recovered from tires

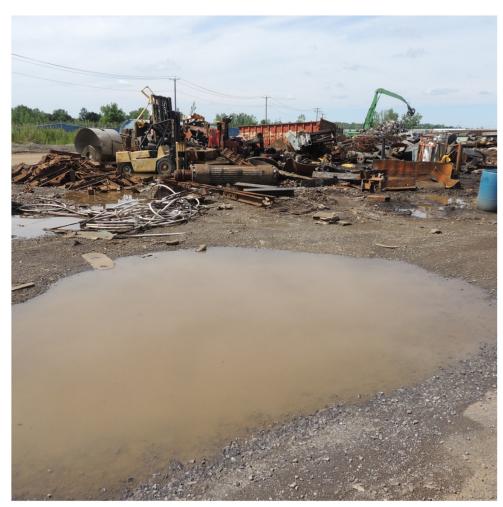
DSCN3618 – unpaved areas – metal scrap storage

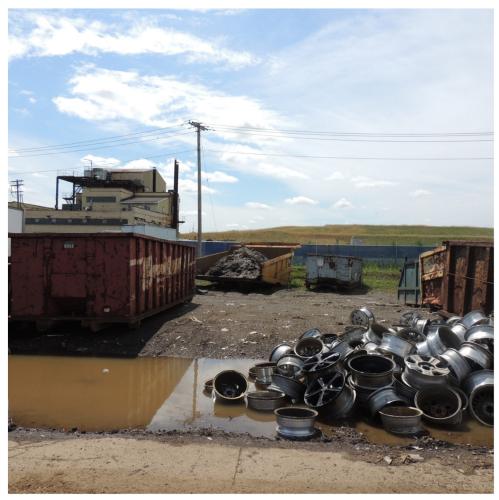
DSCN3619 – hubcap and other material storage bins

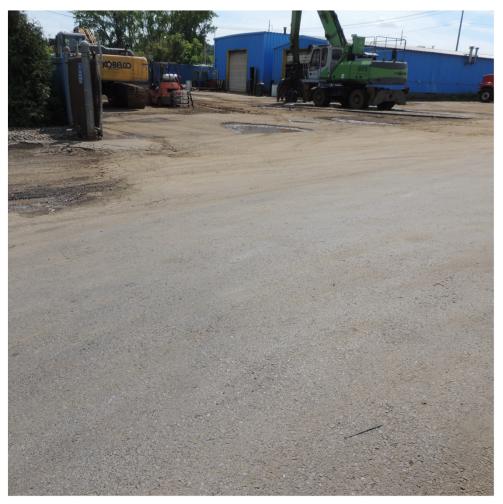
DSCN3623 – Entrance area – Bridge Street Stormwater Outfall 003 some trackout seen

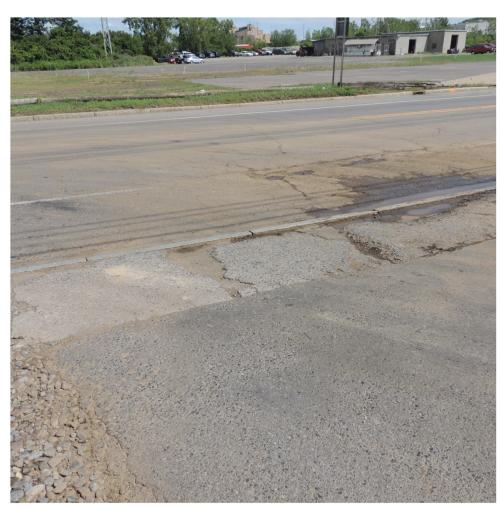
DSCN3624 - Entrance area – Bridge Street Stormwater Outfall 003 some trackout seen

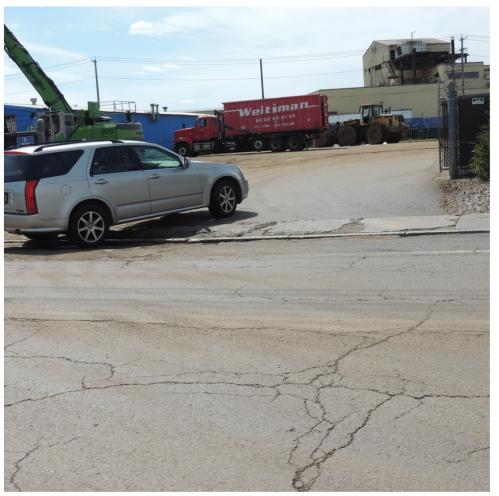
DSCN3625 - Entrance area – Bridge Street Stormwater Outfall 003 some trackout seen

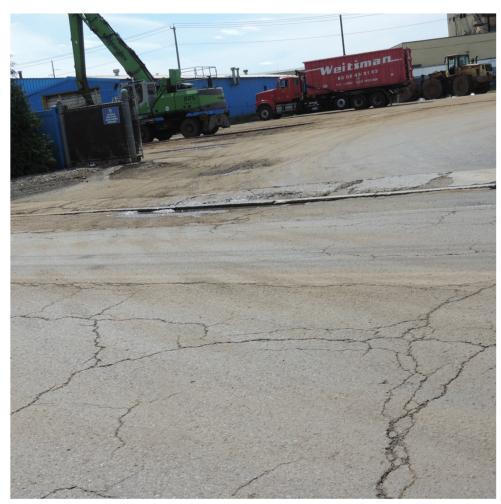
DSCN3626 - Entrance area – Bridge Street Stormwater Outfall 003 some trackout seen

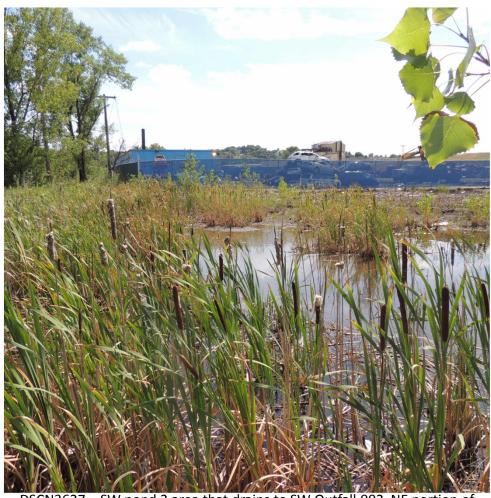
DSCN3627 – SW pond 2 area that drains to SW Outfall 002 NE portion of site near fluids draining operation

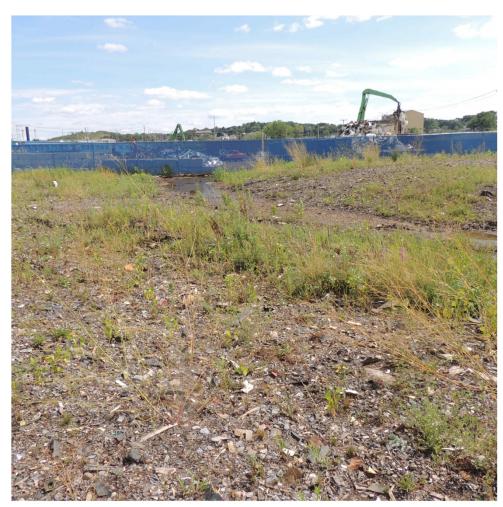
DSCN3628 – SW drainage pathway to SW Outfall 001 from NW portion of site

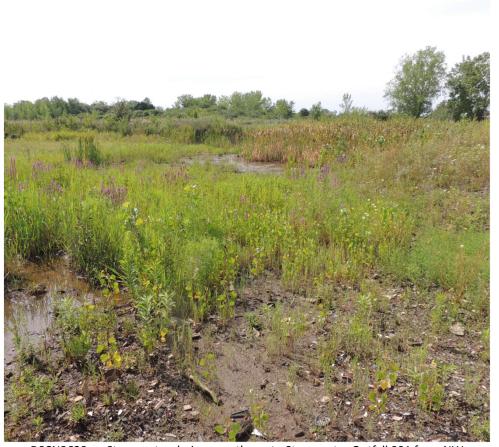
DSCN3629 - – Stormwater drainage pathway to Stormwater Outfall 001 from NW portion of site

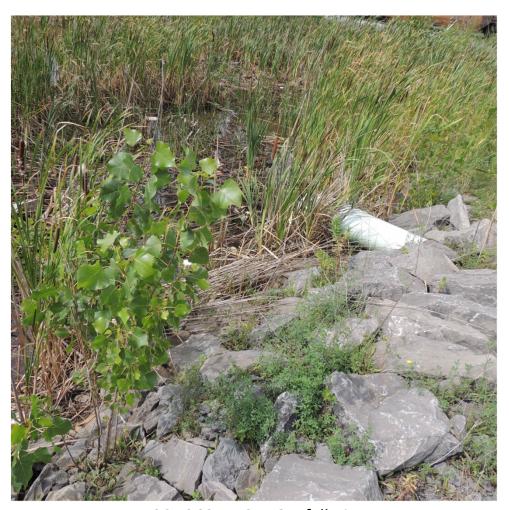
DSCN3631 – SW Outfall Pipe

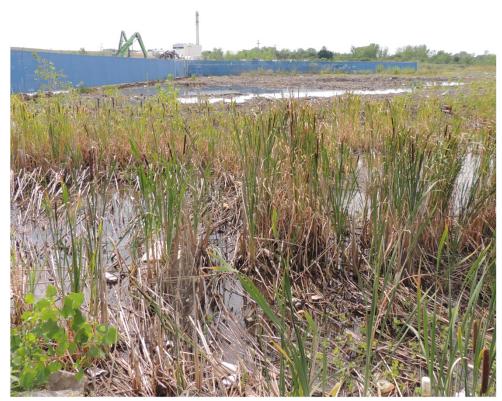
DSCN3632 – SW Management area – 1 in the background

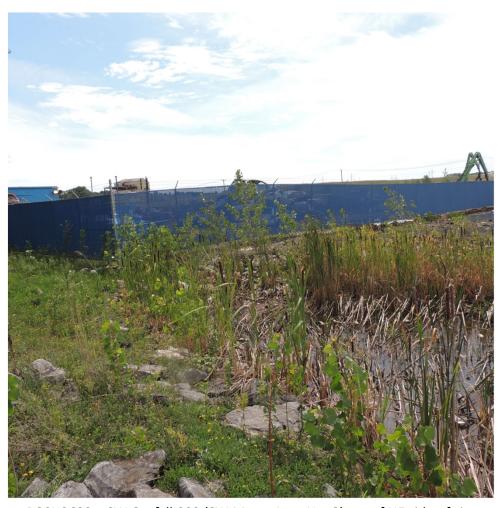
DSCN3633 – SW Outfall 002 (SW Mgmt Area No. 2) are of NE side of site
